The Case of the Three Coats That Won't Cover

By Brian O'Farrell, Owner of DP Coatings LTD

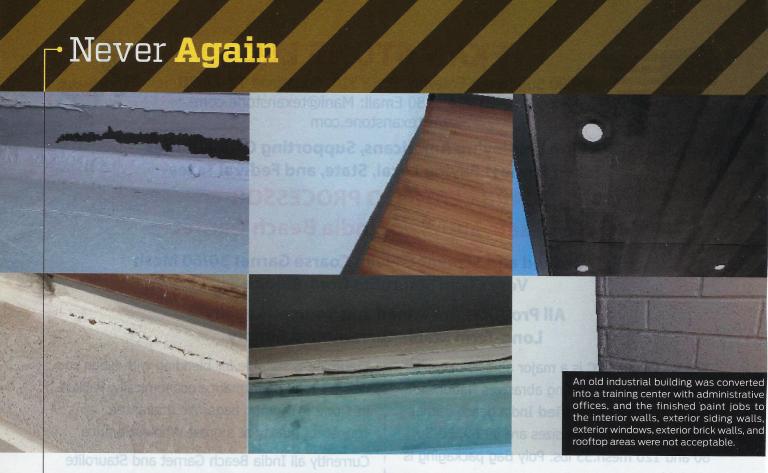
No stain was seen on the window return
